# What About Those Crankshafts?

By Lance Schall

## WHAT IS THIS I HEAR ABOUT BROKEN CRANKSHAFTS?

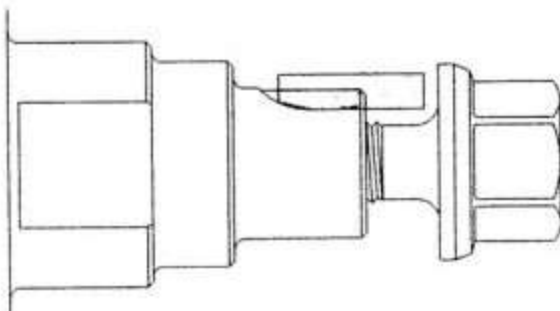
*Short nose -  
small bolt shoulder and 4 slots in  
pulley*

*Big nose -  
larger bolt shoulder and 8 slots in  
pulley*

**Figure 1** - This is a cutaway diagram of the original crankshaft and cam sprocket assembly. Note the incomplete engagement of the key in the short crankshaft slot. Engagement area of the key in the crankshaft slot is 0.045 in<sup>2</sup>.

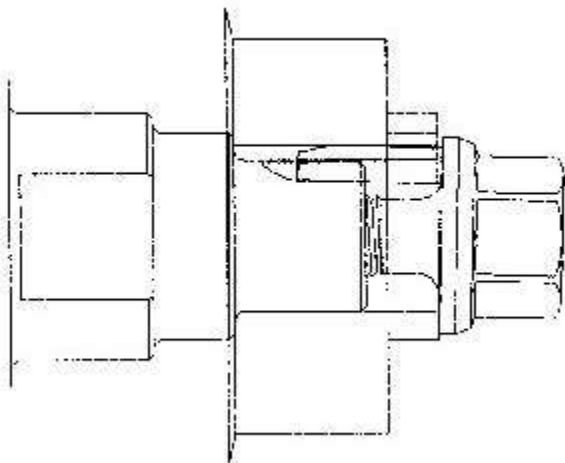
**Figure 2** - *With the chamfered end of the square key incorrectly positioned, the key is forced out of sprocket slot and the bolt shank may be bent. This assembly will not survive long.*

I suggest that improper assembly, reversing the key, is one failure mode. Although there is a figure in this article (Figure 2) showing a reversed key, the text points out that there are several other ways to cause the chain of events leading to failure. It is my fault for writing the article in a way that inappropriately emphasizes the reversed key issue. I have always believed this failure mode to be relatively rare.

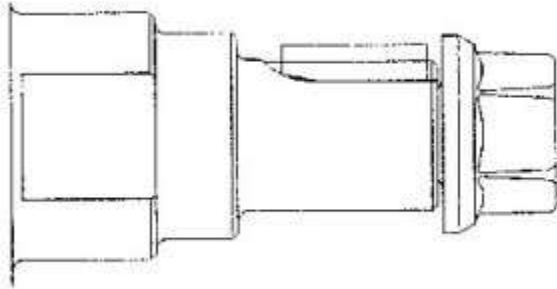
**Figure 3** - A quick fix was provided with a longer nose on the crankshaft. The key is supported along its entire length.

*Engagement area of the key is almost exactly doubled at 0.087 in<sup>2</sup>. The longer nose also prevents the key from rotating out of its slot. If it is inserted upside-down, it may protrude beyond the face of the sprocket further. Hopefully, this makes an error more noticeable before the bolt is tightened.*

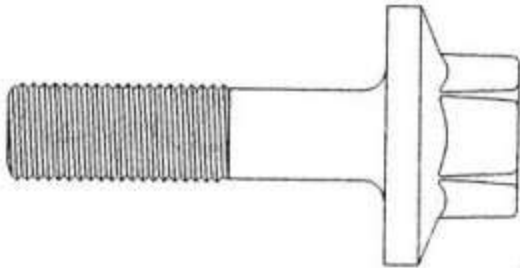
**Figure 4** - Upper; Original bolt length is 2.1 inches and shank diameter is 0.428 inches. Rockwell hardness is 36 on a C scale. Lower; Larger bolt is 2.9 inches long for re-designed crankshaft. Diameter is increased to 0.507 inches. The diameter doesn't seem that much larger but it does represent a 40% larger cross section. The hardness of the large bolt is 22 Rc.

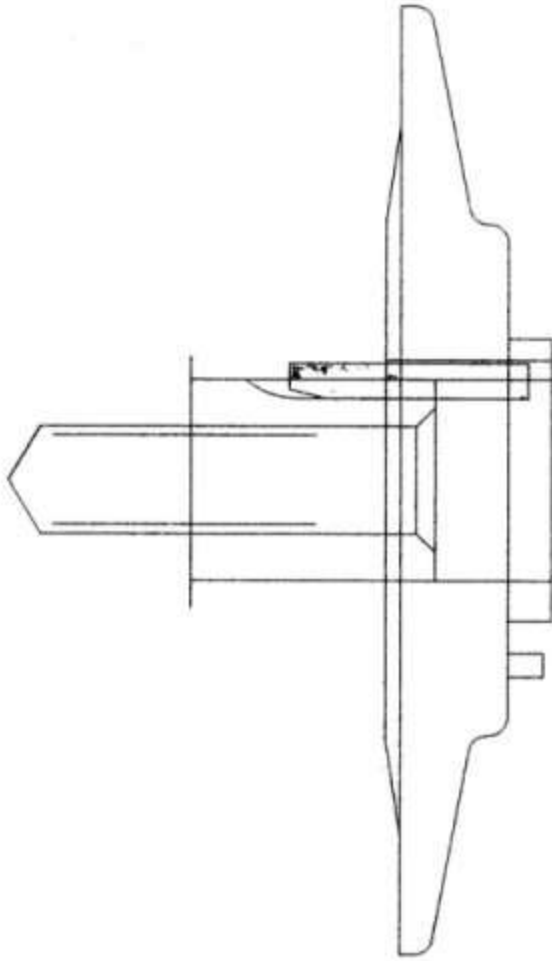
**Figure 5** - Re-designed crankshaft with increased nose diameters. Shown next to original design for comparison. Note the addition of a "pulley boss".

We are fairly sure the long nose crankshaft is reliable. However, if you have more money than you know what to do with, your Miata can help you. Yes, the 1991 1/2 to 1993 crankshaft can be retrofitted to an early Miata. The crankshaft, pulley bolt, cam sprocket, front seal, pulley, spacer, and oil pump must be replaced as a set. I am not sure about the front cover. At least we know the engine block was not changed for the entire life of the Miata 1.6 liter. Realize that the dealer's references will not completely document this conversion. It is easy enough to do, but you have to play detective with the parts book. Understandably, Mazda did not provide the dealers with details for putting a 1992 crankshaft in a 1990 car. If any Peak To Peak Miata Club members want to do this conversion, your newsletter editor would welcome the opportunity to be a technical consultant. That is, if necessary, you can watch me while I do the work! By the way, an entire engine from a 1992 or 1993 will directly bolt into a 1990 Miata. This is a nice way to get the stronger crankshaft (Figure 5). Keep this in mind if you go with the engine replacement plan.
