## “WENCH WITH A WRENCH”

### Your PCV Valve Sucks, Really!

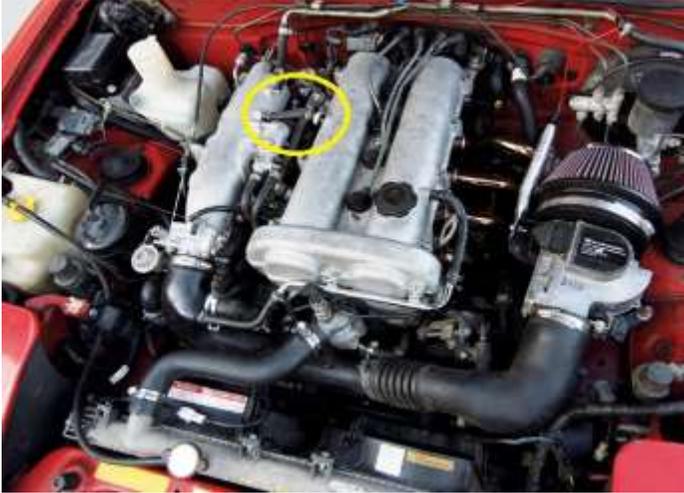
PCV located on top of valve cover:

You can easily find the PCV as it is usually mounted in a grommet on the top or side of the engine valve cover at the end of a hose or tube or hidden underneath the intake manifold in later Miata models and can be either a small straight or L-shaped plastic piece.

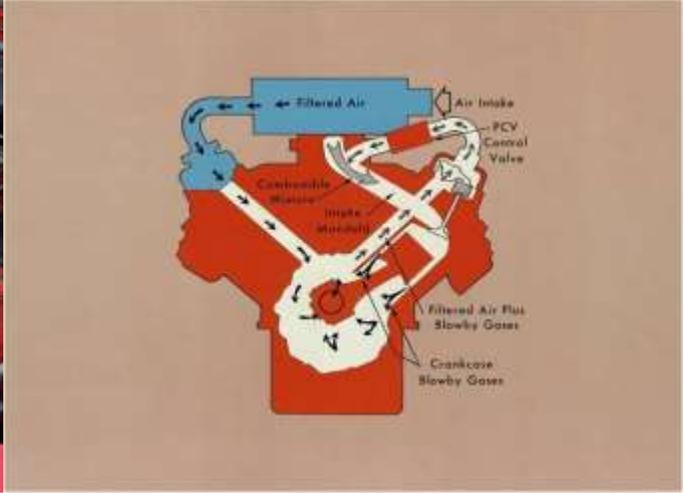
PCV System Illustrated:

Basically, the PCV system takes leftover combustion gases (called “blow-by”) from inside the crankcase (the oil pan and bottom of the engine) and routes them back into the intake manifold where they’re burned in the combustion chamber instead of allowing hydrocarbons, a major source of air pollution discovered in the 1950’s, to escape into the atmosphere. Pretty cool, huh?

So, the PCV is essentially a metered “leak of air” into the intake system sucking all of its input from the crankcase. You can’t have a big air leak happening all the time or your car wouldn’t idle worth a damn. (Whoops, I mean *darn*.☺) The valve receives a signal when there are greater fumes to scavenge. Ergo, throttle shut (at idle) = not much fumes; throttle open (when you step on the gas) = lots of fumes to suck back to the intake manifold for burning.
