TECHNICAL TIPS – “Wench With A Wrench”
By Gail Wagner – Midstate Miata Club of NY

Keeping the NC Engine From Exploding (I'm Not Kidding)

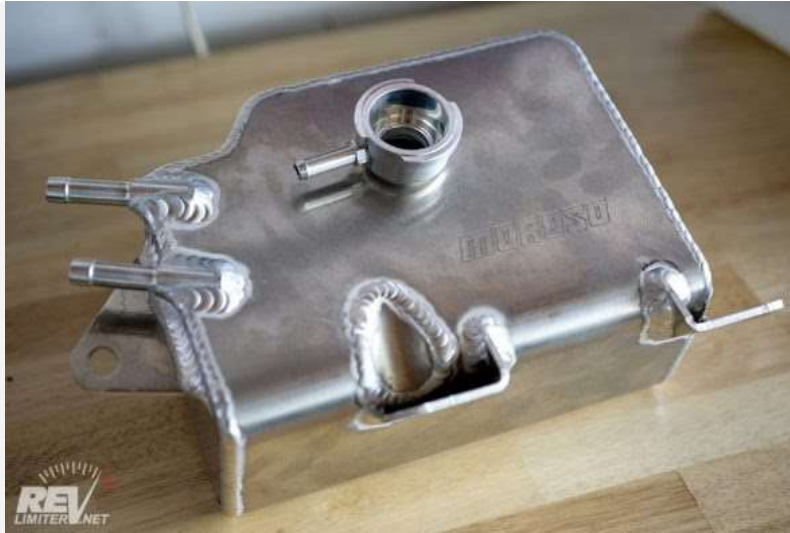
Shiny metal goodness.

In the past couple weeks, I've learned a lot of trivia about NC Miatas. Facts such as – the coolant bottle in the NC is pressurized. And also – said pressurized coolant expansion tank is prone to cracking and failing after a random number of miles. Sometimes it's a high mileage like 140k. Sometimes it's quite low like 14k.

Enter the metal bottle done by Moroso and Goodwin Racing. No more expansion tank explosions.

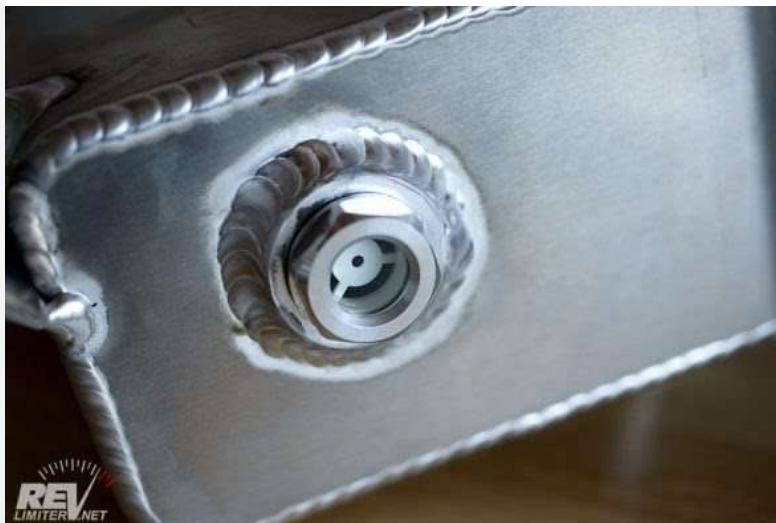
Sight glass.

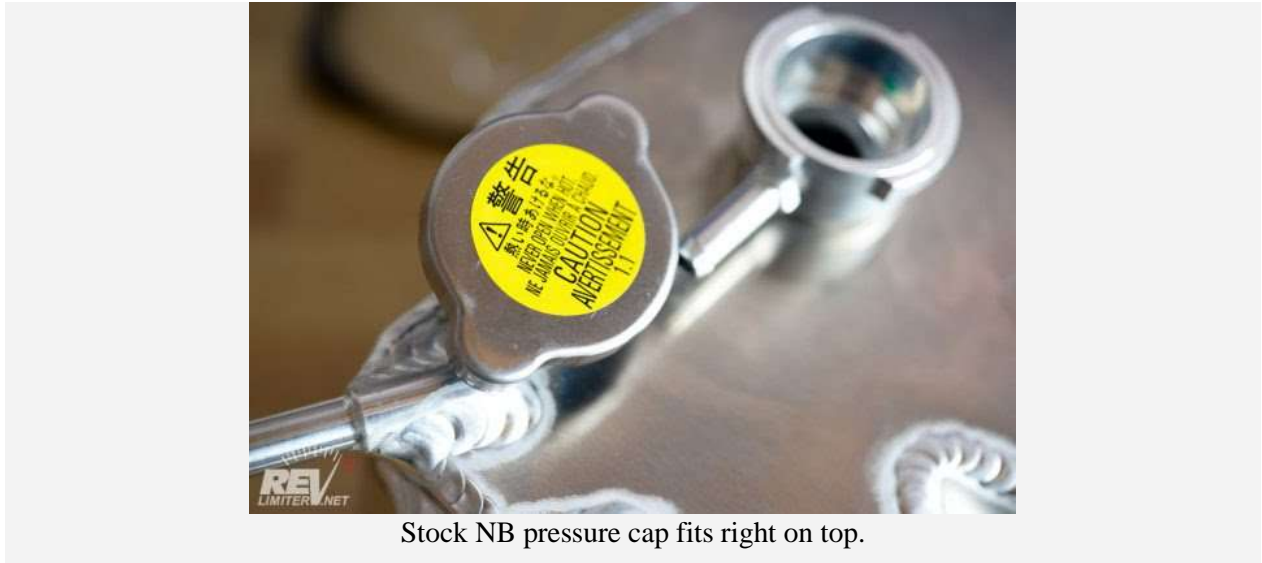
This is a very nicely welded piece. It’s got internal baffles just like the stock bottle. It bolts on just like stock and has all of the correct hose outlets. It’s also got a nice sight glass so that you can see if there’s anything inside the little metal bottle.

It costs about 4x the price of a new plastic bottle from Mazda. But it should be a lifetime part without any failure points.

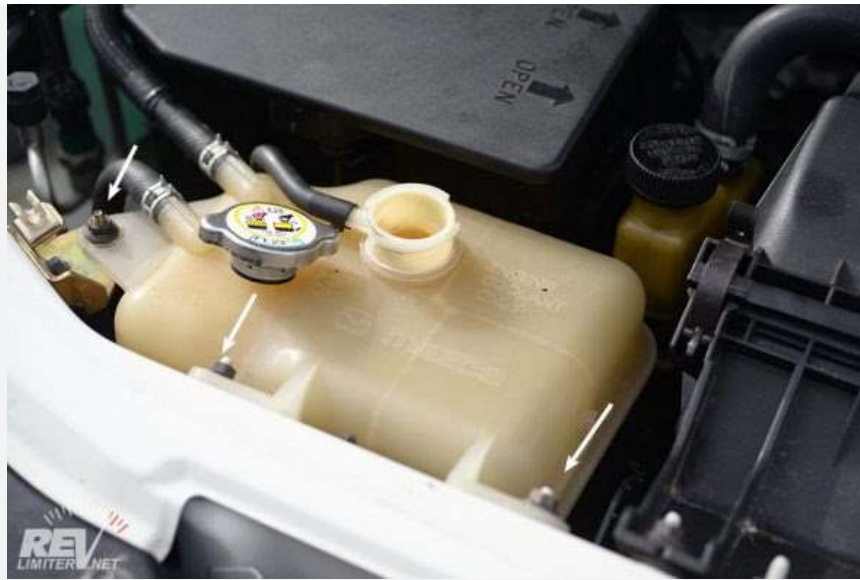
Old bottle screw points.

The bottle is held in by 3 nuts.

3 bolts with 10mm heads. All on top and not hidden. EASY!

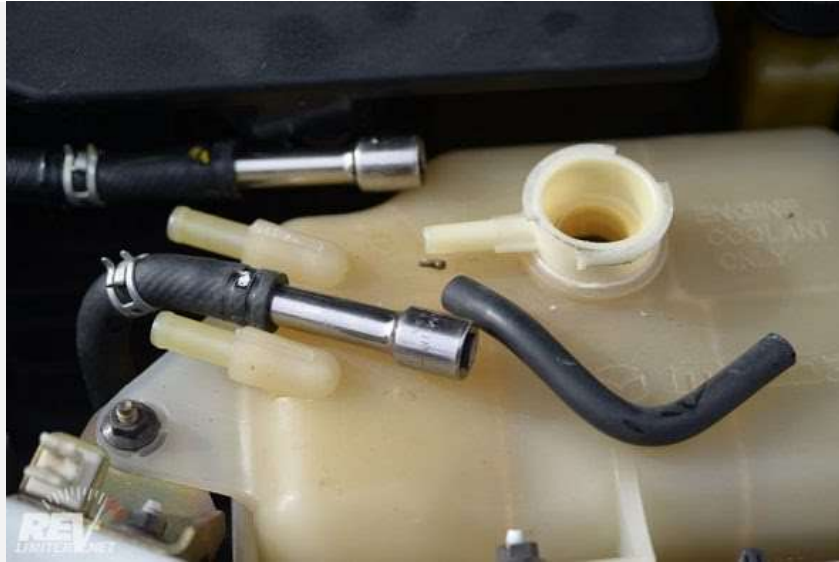
Plugged.

No coolant was really in danger of coming out, but I didn't wanna take any chances. And I've got plenty of 3/8" socket extensions.

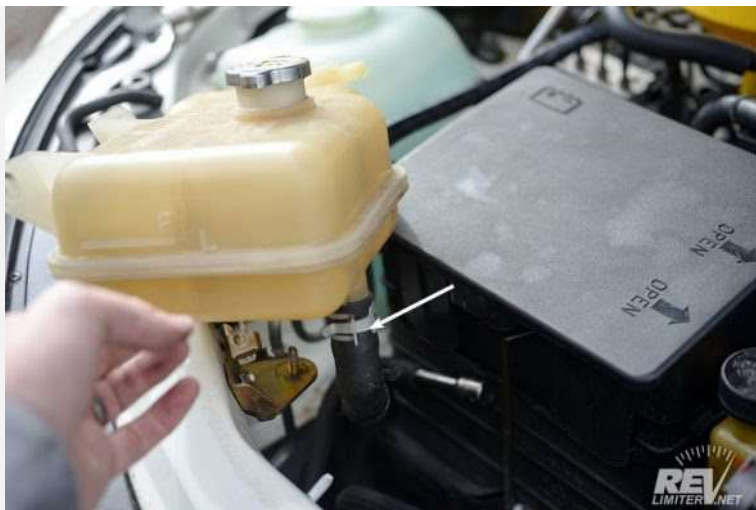
One large hose at the bottom.

There's a large hose at the bottom of the reservoir that needs to come off. I quickly removed it and held the tank over top of my spillproof funnel. I didn't spill any this way.

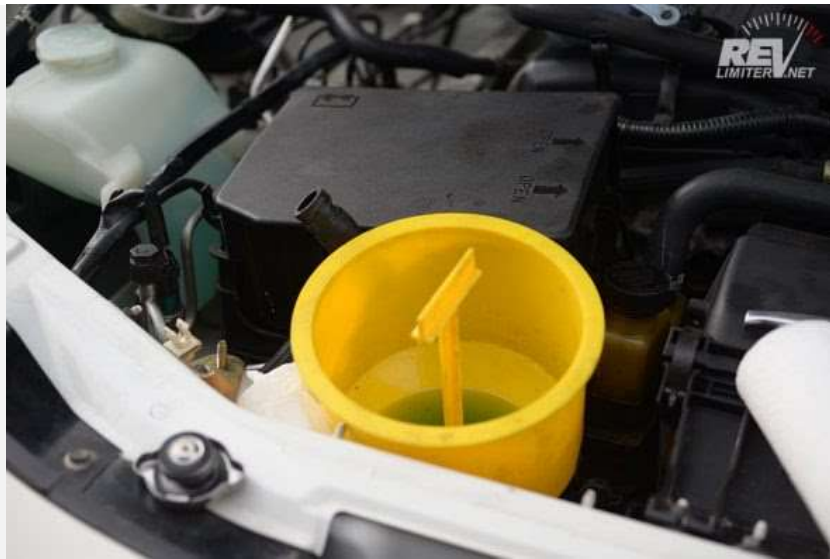
Bucket.

After I got all the fluid out of the reservoir, it got tossed aside and I bolted on the new metal one.

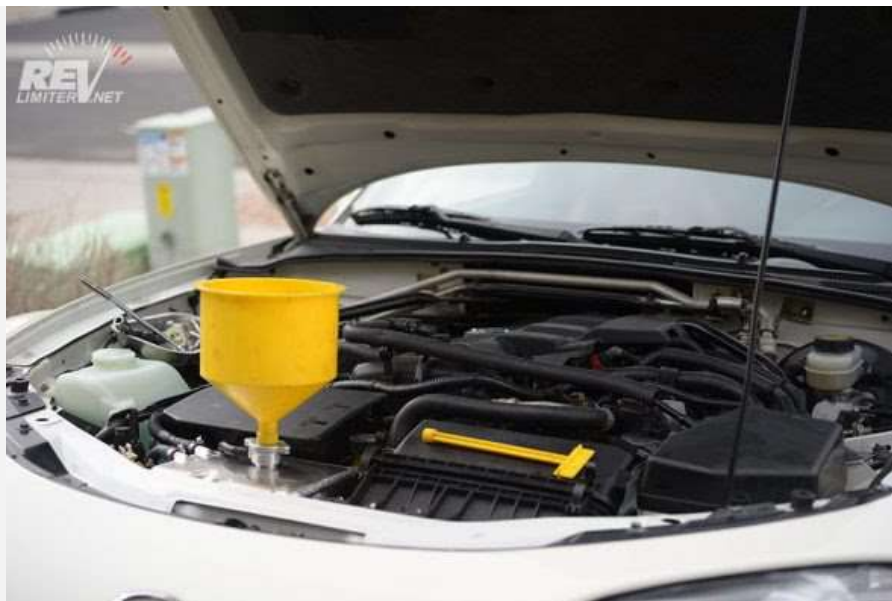
Ready for filling and burping.

I burped the NC radiator just like I would an NA or NB. I filled the bottle ALL the way up with the car jacked up and added a few inches of distilled water to the funnel. That put the highest water level inside the funnel.

If anyone reading decides to burp an NC like I did, realize that you've gotta siphon some fluid back out of the expansion tank after you're done. It's an expansion tank after all and is not meant to be full like a radiator is. Drain it to somewhere on the sight glass or below the "full" mark on the OEM bottle.

Anyways, like I said, I burped the radiator this way. I had no problems. I squeezed the hoses on the back side of the engine and got a lot of big bubbles out. I ran the car for a good 20 minutes and let the thermostat cycle open and closed many times (as seen on my OBDII scanner).

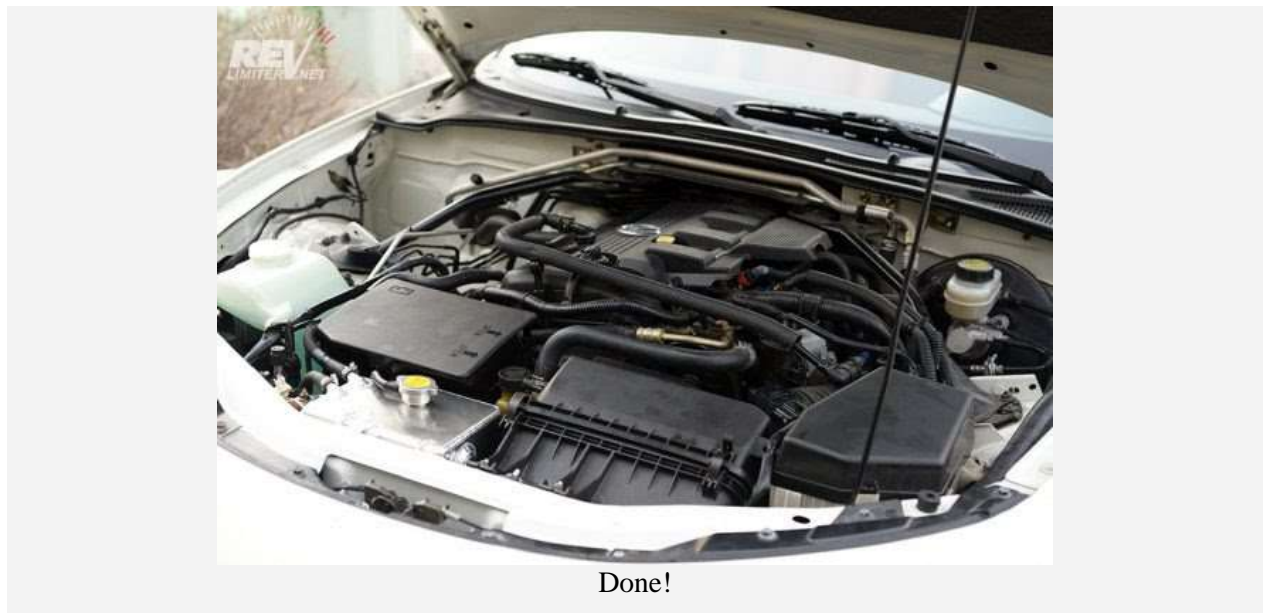
So much black plastic in that engine bay...

And no exploding coolant bottles to be found anywhere. WOO HOO!!!

After burping, I took a test drive. The engine stayed between 179* and 186*F. (So odd having an ECU that reads in Imperial – Sharka is metric.) No overheating or bad behavior. And the heat blows HOT inside the car!! It's never been so nice and warm.
